INQUIRY INTO THE COLLAPSE OF TEXAS TOWER NO. 4

HEARINGS

PREPAREDNESS INVESTIGATING SUBCOMMITTEE

COMMITTEE ON ARMED SERVICES

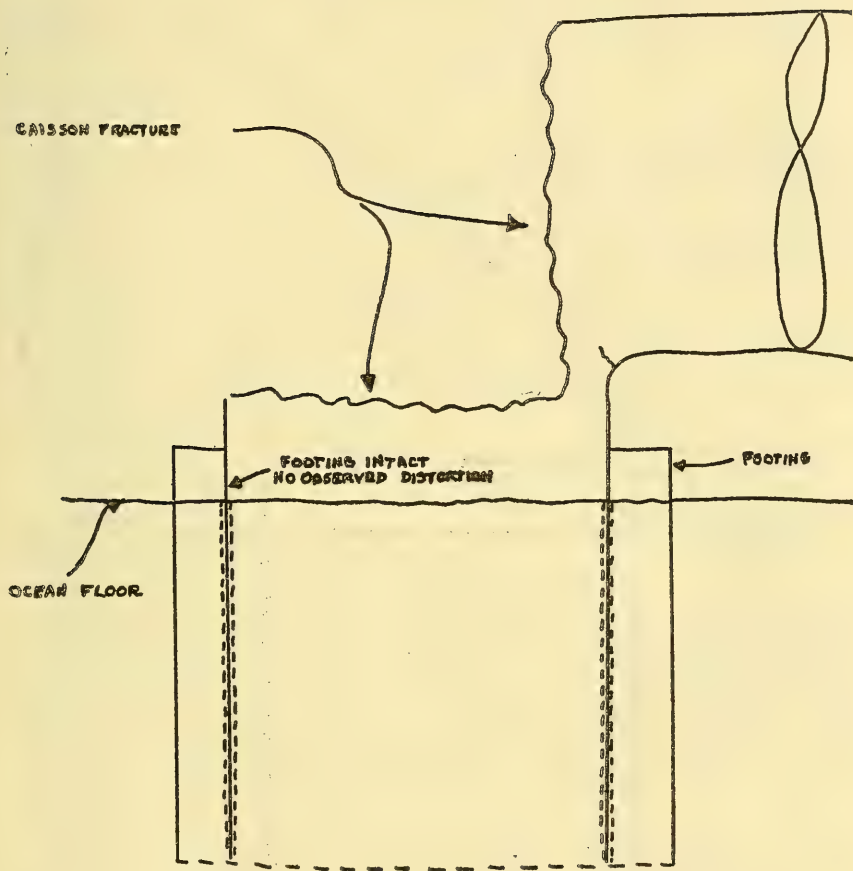
TEXAS TOWER NO 4
TYPE FRACTURE
CAISSON "A" + "C"

CAISSON FOOTINGS
"A" + "C"

PHOTOS SHOW PARTS OF FRACTURE

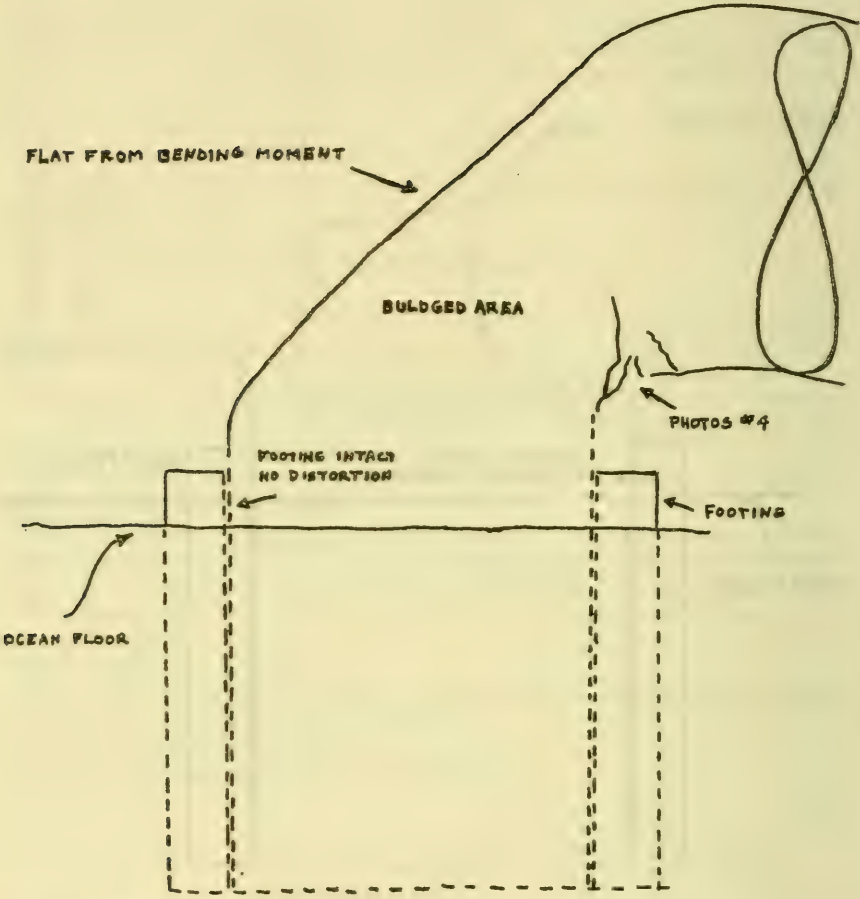
TEXAS TOWER NO 4
BENT CAISSON "B"

SEVERAL PHOTOS #4
OF FRACTURED END
